Historic Furnishings Report Painted Desert Inn

Volume 1: Historical Data
Volume 2: Implementation Plan

Petrified Forest National Park
Petrified Forest, Arizona

**Northeast Museum Services Center
National Park Service
May 2004**

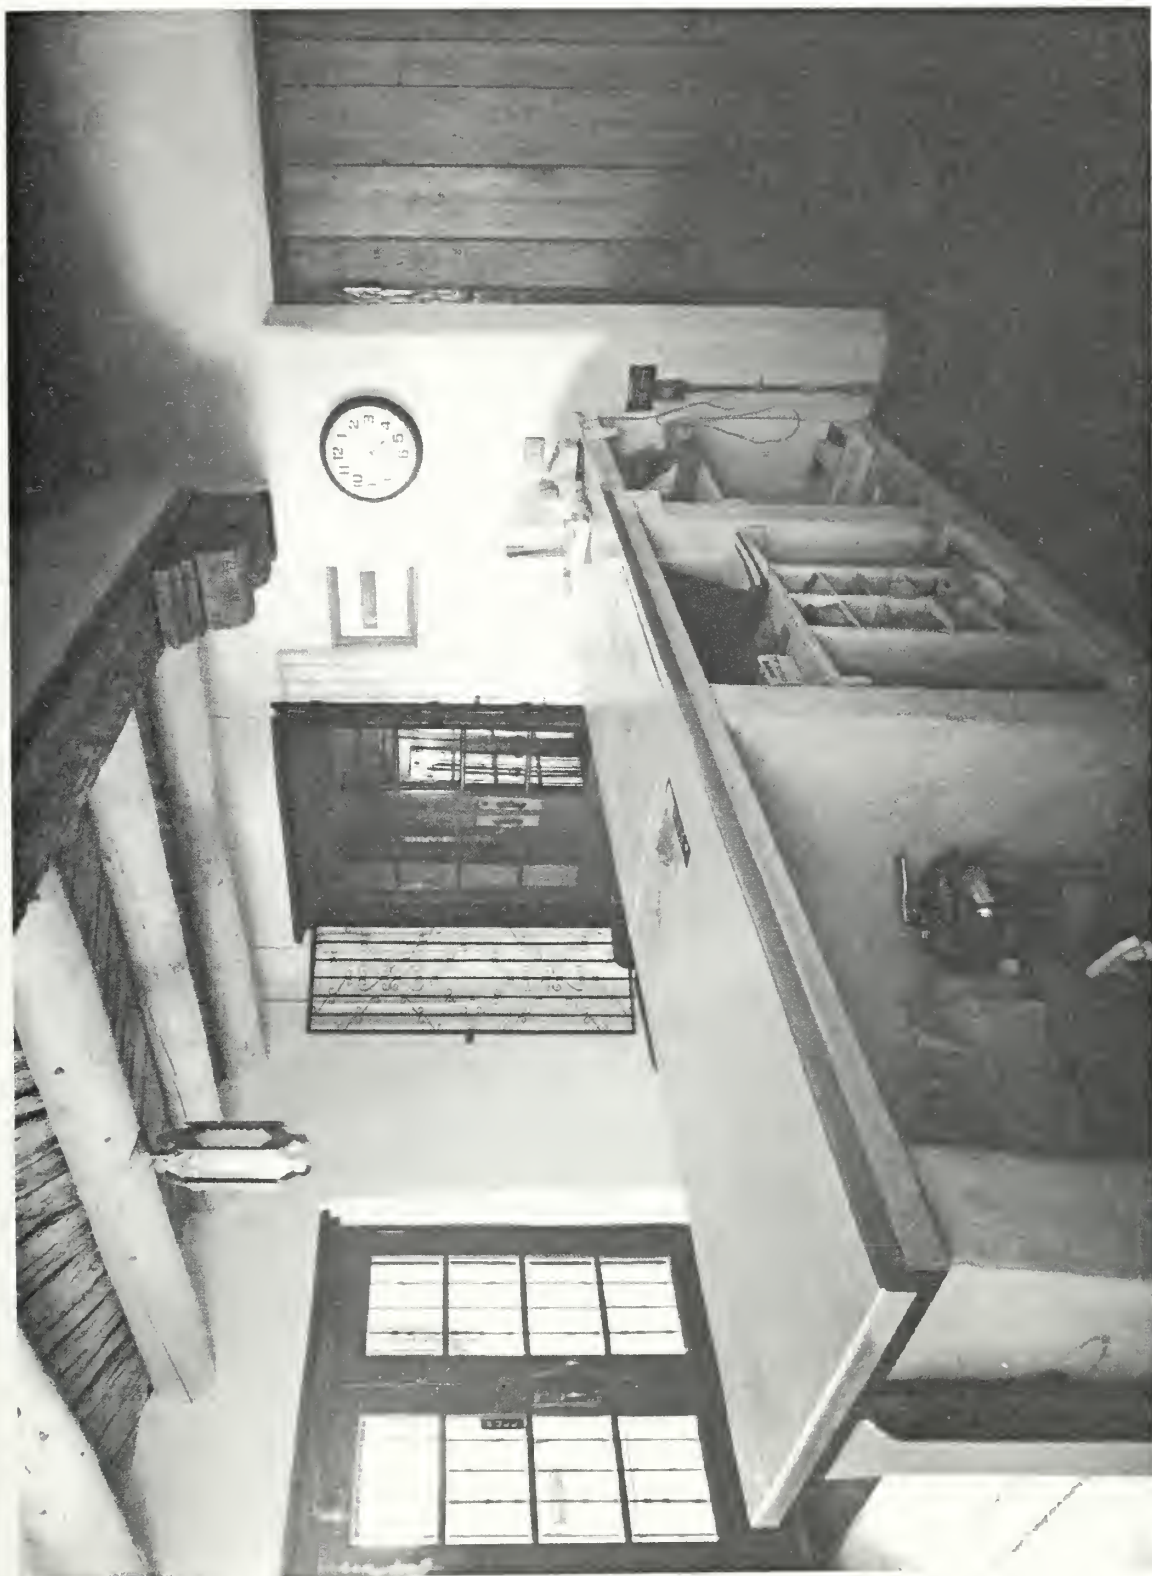
68. "Public Entrance, (Room 105)." 1975, Unidentified Photographer, Museum Collection, Archives, Petrified Forest National Park, Petrified Forest, Arizona, PEFO CAT. # 20730.

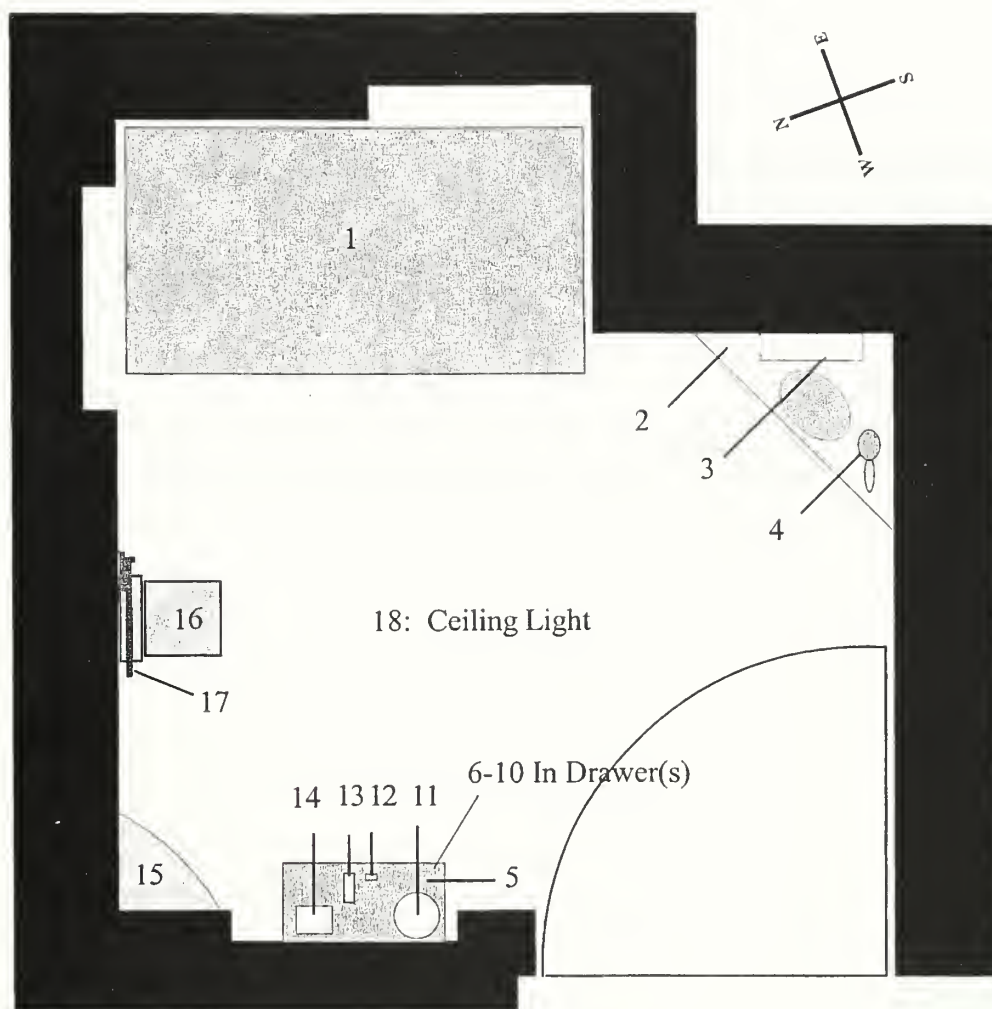
Room 10-Employees' Room

1. Painted Desert Inn, Room 10, Recommended Objects for Employees' Room Installation, plan by Laura DeNormandie.

Should the park choose to install a historic furnished interior in Room 10, Guest Room/Employees' Room, the plaster will require repair due to its current poor condition.

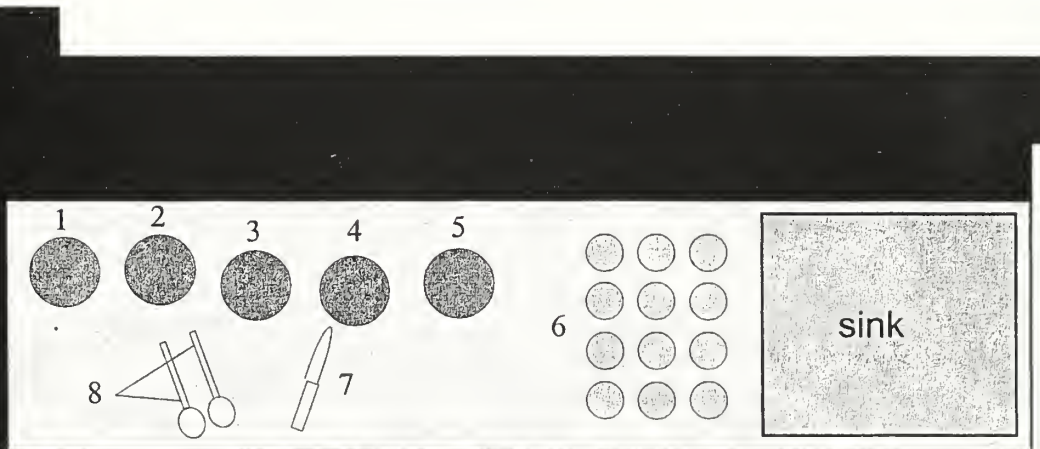
Room 101-Kitchen
Recommended Objects for
"Salad Table Vignette"

2. Painted Desert Inn, Room 101--Kitchen, Recommended Objects for
“Salad Table Vignette” Installation, Plan by Laura DeNormandie.

Room 101's entry hall (visible through a window in the kitchen door located in the lunchroom) is presented as a historic furnished vignette. The vignette will incorporate the historic dumbwaiter, cabinets, and countertop with a view to the east wall sinks (all located along the east wall of the kitchen hallway). It is recommended that the two swinging doors to the dining room located in the west side of the hallway be reopened. They are currently sealed with unfinished gypsum board. As there are no extant kitchen furnishings or utensils in the museum collection, reproduction or vintage replacement utensils need to be acquired to complete this vignette.

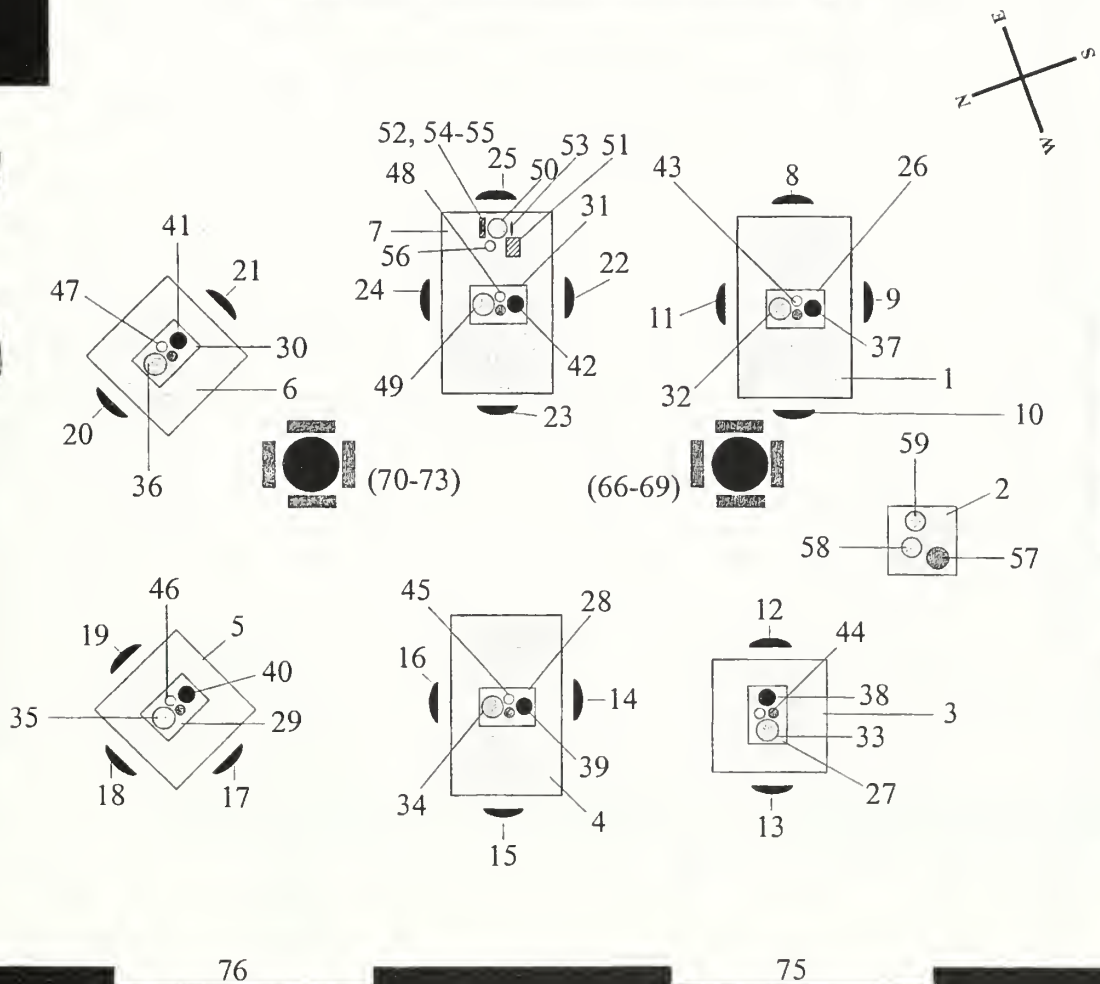
Room 102-Dining Room

3. Painted Desert Inn, Room 102--Dining Room, Recommended Objects for Dining Room Installation, Plan by Laura DeNormandie.

Room 102 will be treated as a historic furnished interior, restored to the early years of management by the Fred Harvey Company (1947 to 1950). The paint scheme for this date is known and it is recommended that it be restored.²³⁶ It is recommended that the doorway from the dining room to the kitchen be reopened. It is also recommended that the 1991 low wooden balustrade and the display case full of Fred Harvey tableware be removed.

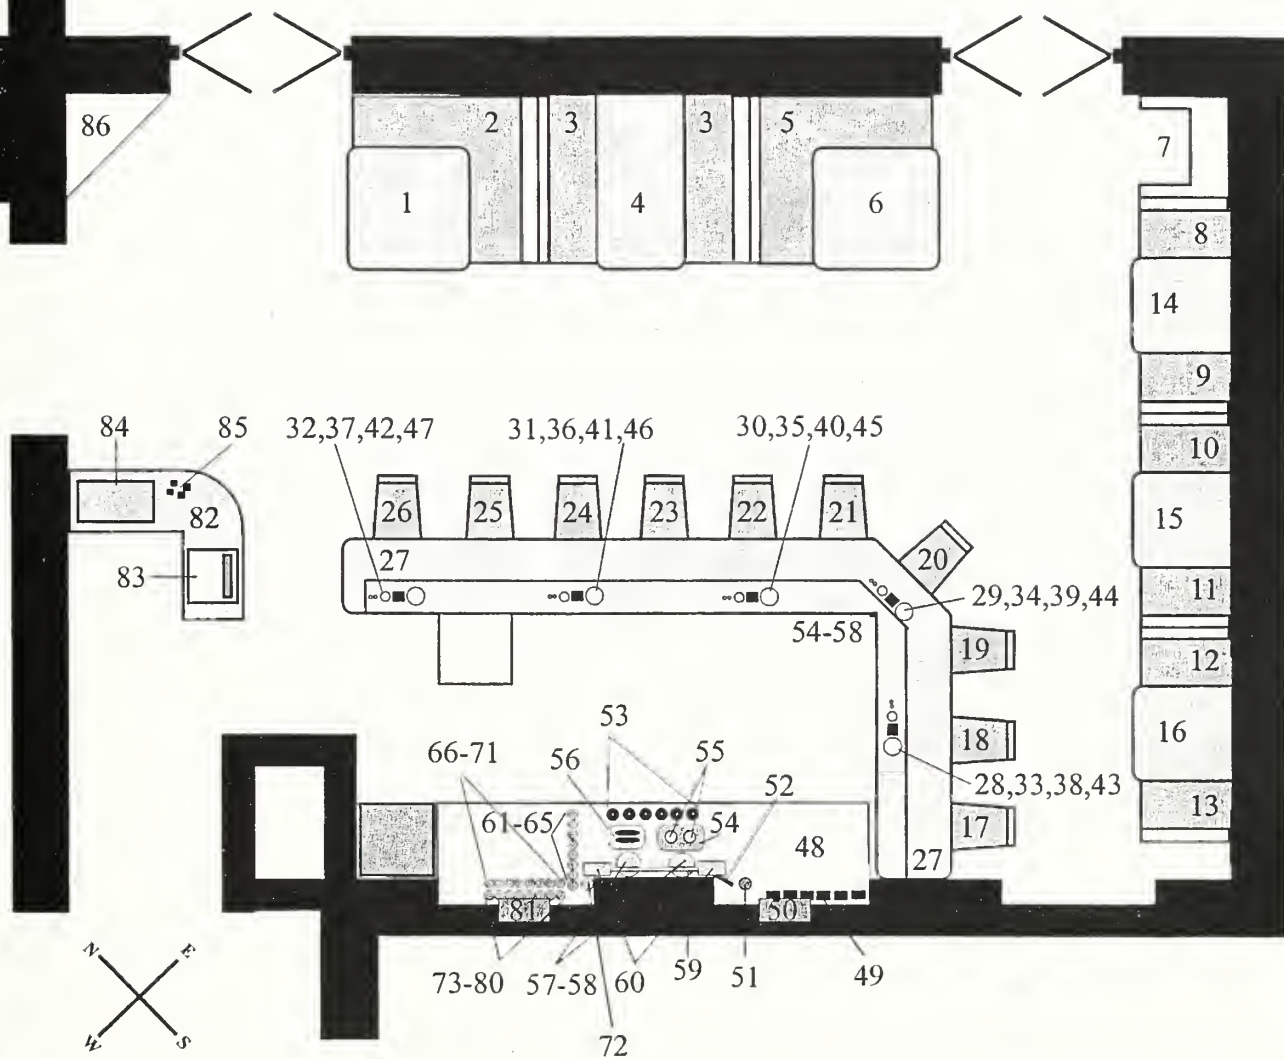
Room 103-Lunchroom

4. Painted Desert Inn, Room 103--Lunchroom, Recommended Objects for Lunchroom Installation, Plan by Laura DeNormandie.

Room 102 will be treated as a historic furnished interior, restored to the early years of management by the Fred Harvey Company (1947 to 1950). The room will contain a soda fountain and lunch counter with stools, seating, and tables lining the perimeter of the room, and a cashier's counter. The lunchroom will be the only historically furnished space to contain all reproduction and replacement objects. While the soda fountain would not be functional, visitors would be able to sit upon lunchroom seating to relax, read interpretive handouts, or view the lunchroom as customers would have historically. The Harvey-era paint scheme of the room's walls, columns, and woodwork is known and it is recommended that it be restored. It is also recommended that the tin chandeliers be conserved and rehung in the lunchroom.

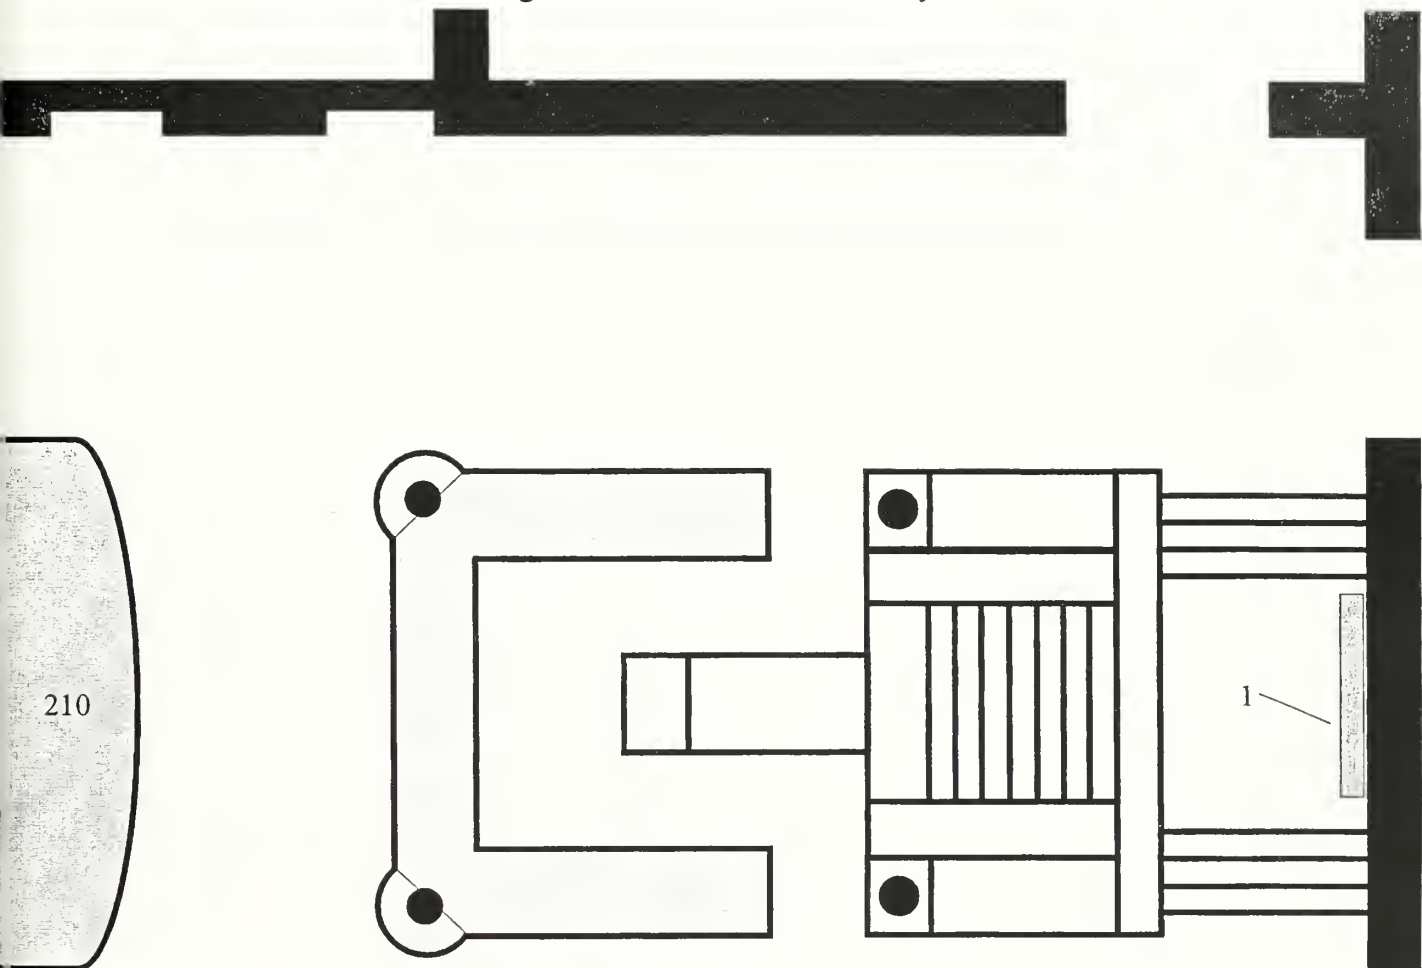
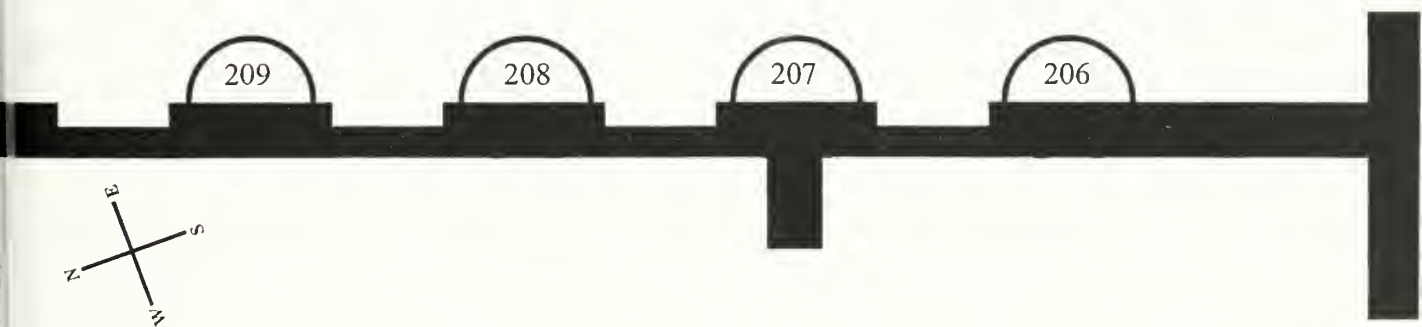
Room 104-Trading Post Room -- Overall Layout

5. Painted Desert Inn, Room 104--Trading Post Room, Overall Layout for Trading Post Room Installation, Plan by Laura DeNormandie.

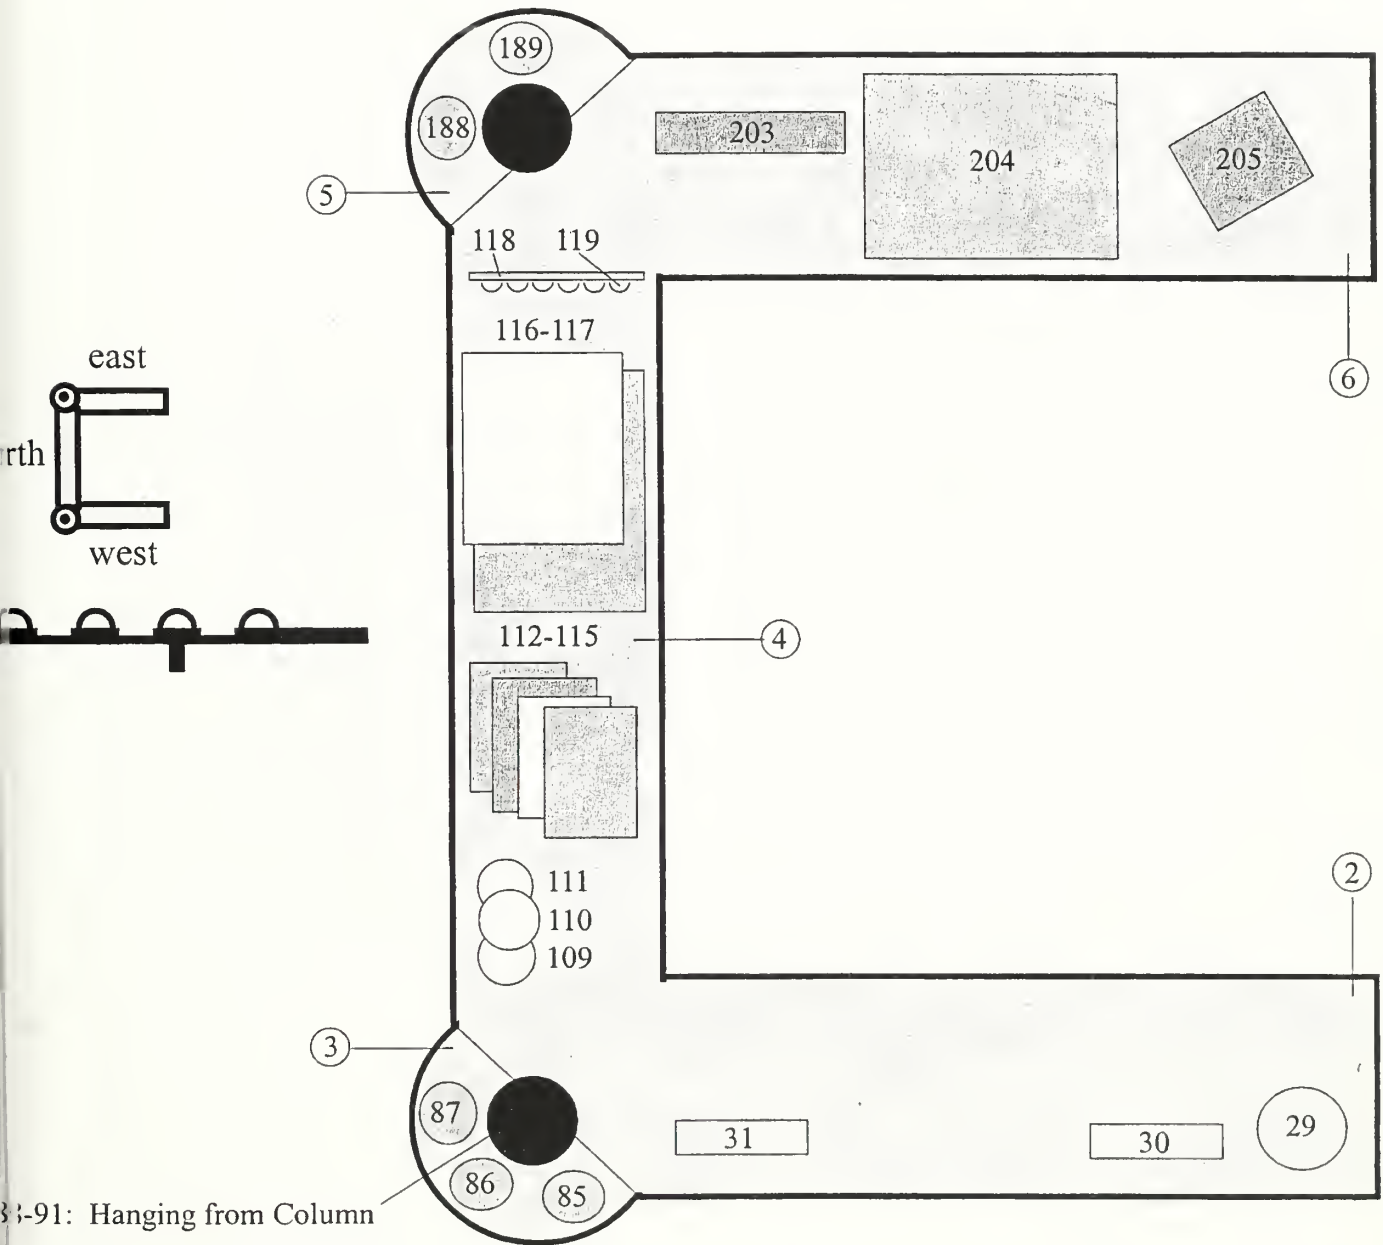
Room 104-Trading Post Room
Top Counter of Display Units

6. Painted Desert Inn, Room 104--Trading Post Room, Recommended Objects for Top Counter of Display Units, Plan by Laura DeNormandie.

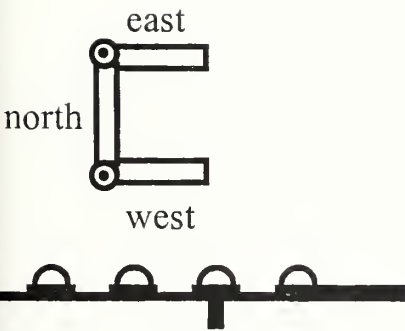
Room 104-Trading Post Room
Upper Shelves of Display Units

7. Painted Desert Inn, Room 104--Trading Post Room, Recommended Objects for Upper Shelves of Display Units, Plan by Laura DeNormandie.

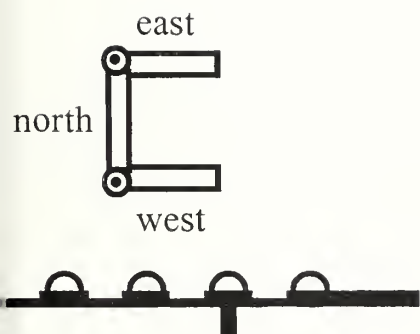
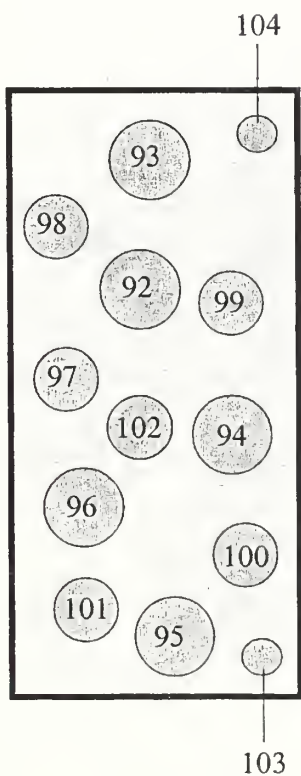
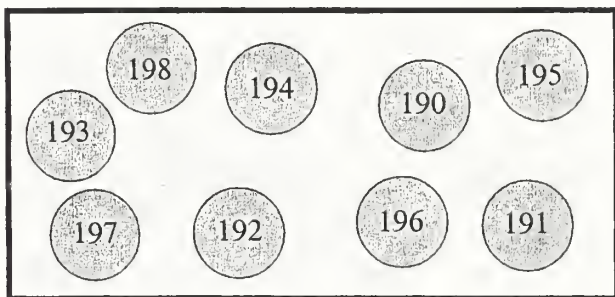
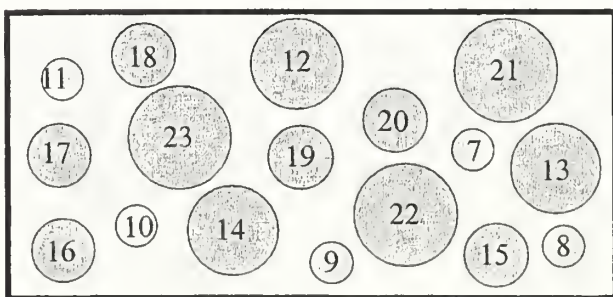
Room 104-Trading Post Room Bottom Shelves of Display Units

8. Painted Desert Inn, Room 104--Trading Post Room, Recommended Objects for Bottom Shelves of Display Units, Plan by Laura DeNormandie.

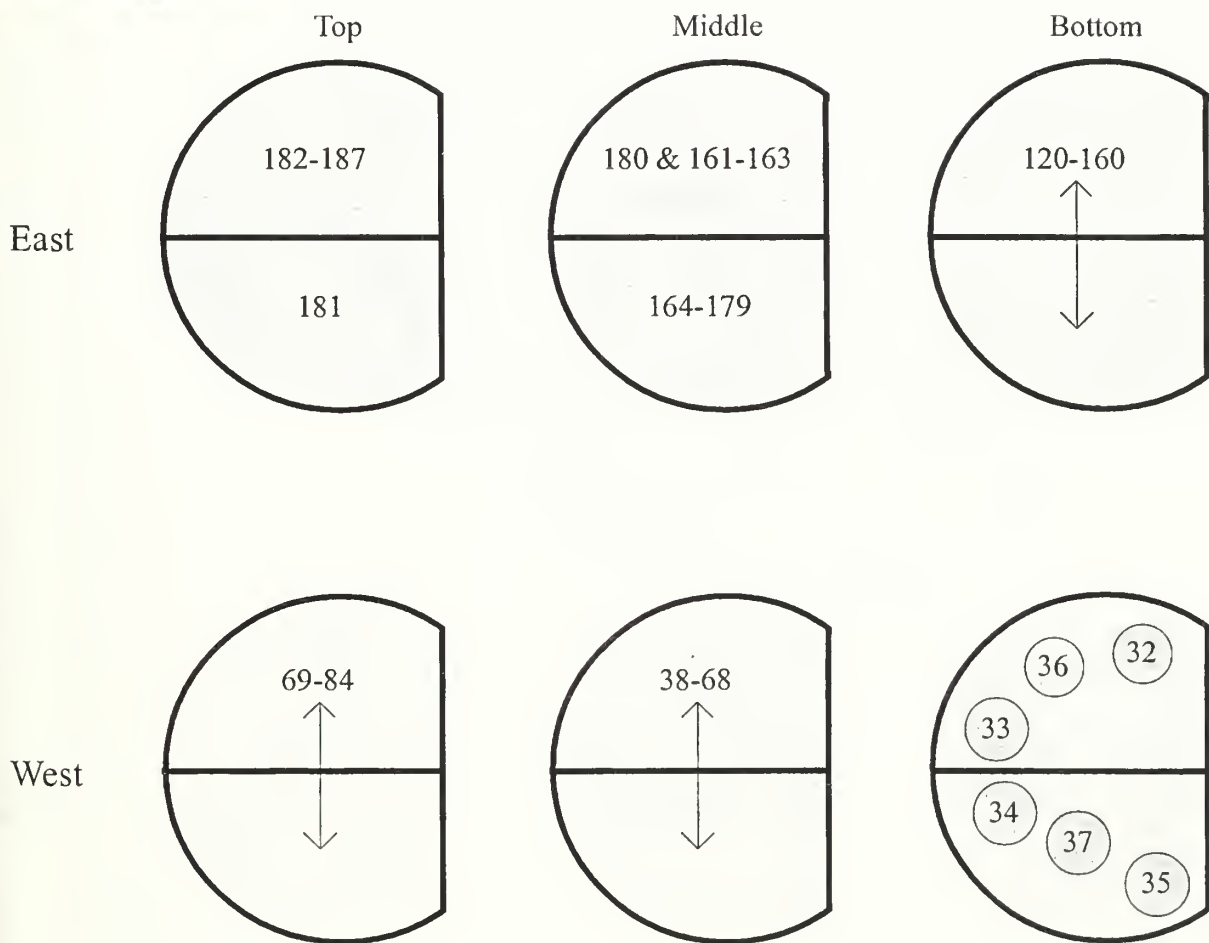
Room 104-Trading Post Room Semi-circular Shelving Units

9. Painted Desert Inn, Room 104--Trading Post Room, Recommended Objects for Semi-circular Shelving Units, Plan by Laura DeNormandie.
